Bioventing at
Operable Units 5, 8, 9, 10, and 11

Loring Air Force Base
SEMIANNUAL PERFORMANCE REPORT
August — December 1997

March 1998
Revision B

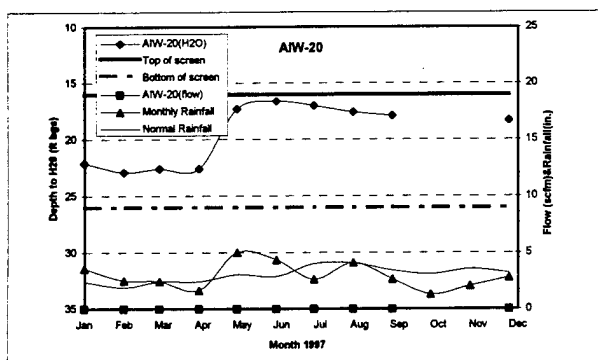
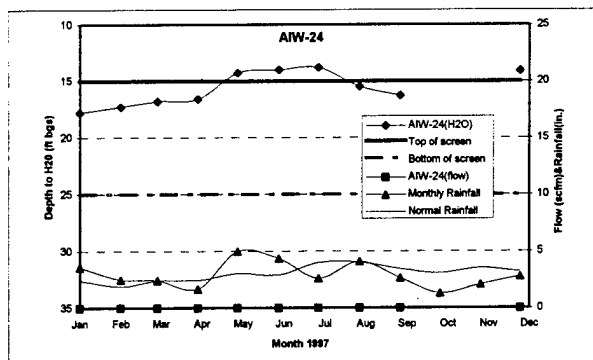
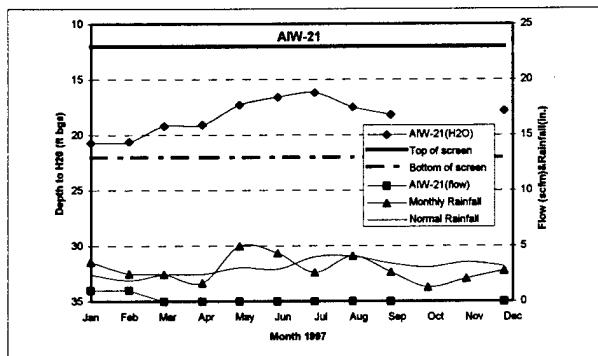
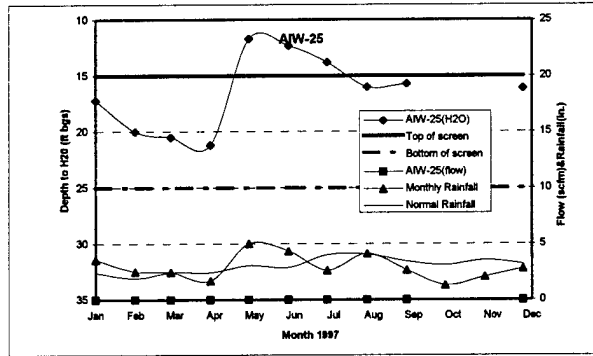
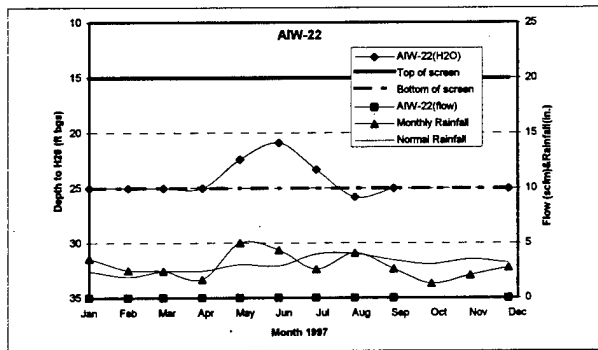
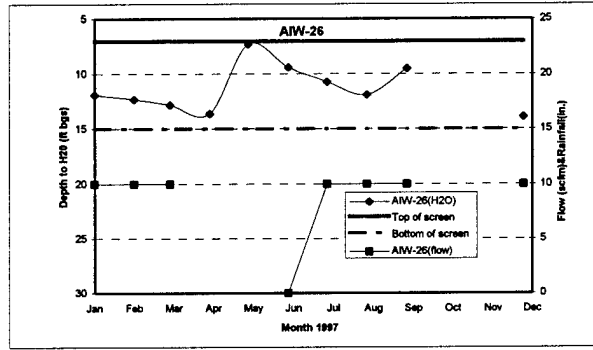
Figure 14-1 Air Flow vs. Depth to Groundwater at NDA-4

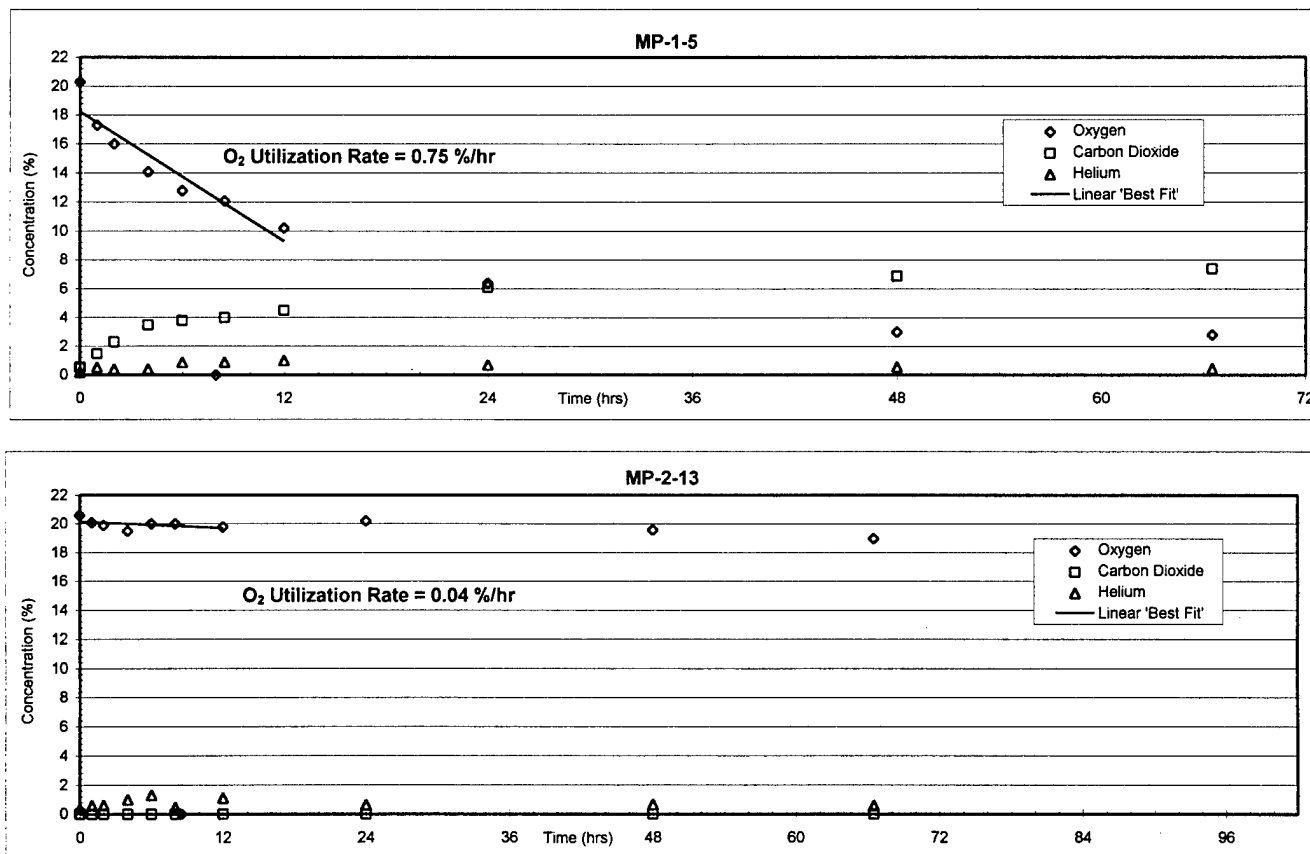
Figure A-1 Fall 1997 Respiration Test Results for MP-1-5 and MP-2-13 at the AHS

Respiration tests performed on October 22, 1997 included four MPs, one of which was a new location not previously tested. Respiration data and results for the respiration tests are shown on Figures A-1 and A-2 (Appendix A). MP 5, tested in the summer, was not tested this time. MPs 2-13 and 4-13 showed results similar to the summer respiration rates; both were at background levels, indicating that biodegradation may be complete. The oxygen utilization rate at MP 1-5 decreased from 1.03 percent/hour in June to 0.75 percent in October—a significant decrease, although still indicative of active biodegradation. An additional MP (MP-9-6.5) was constructed in August.

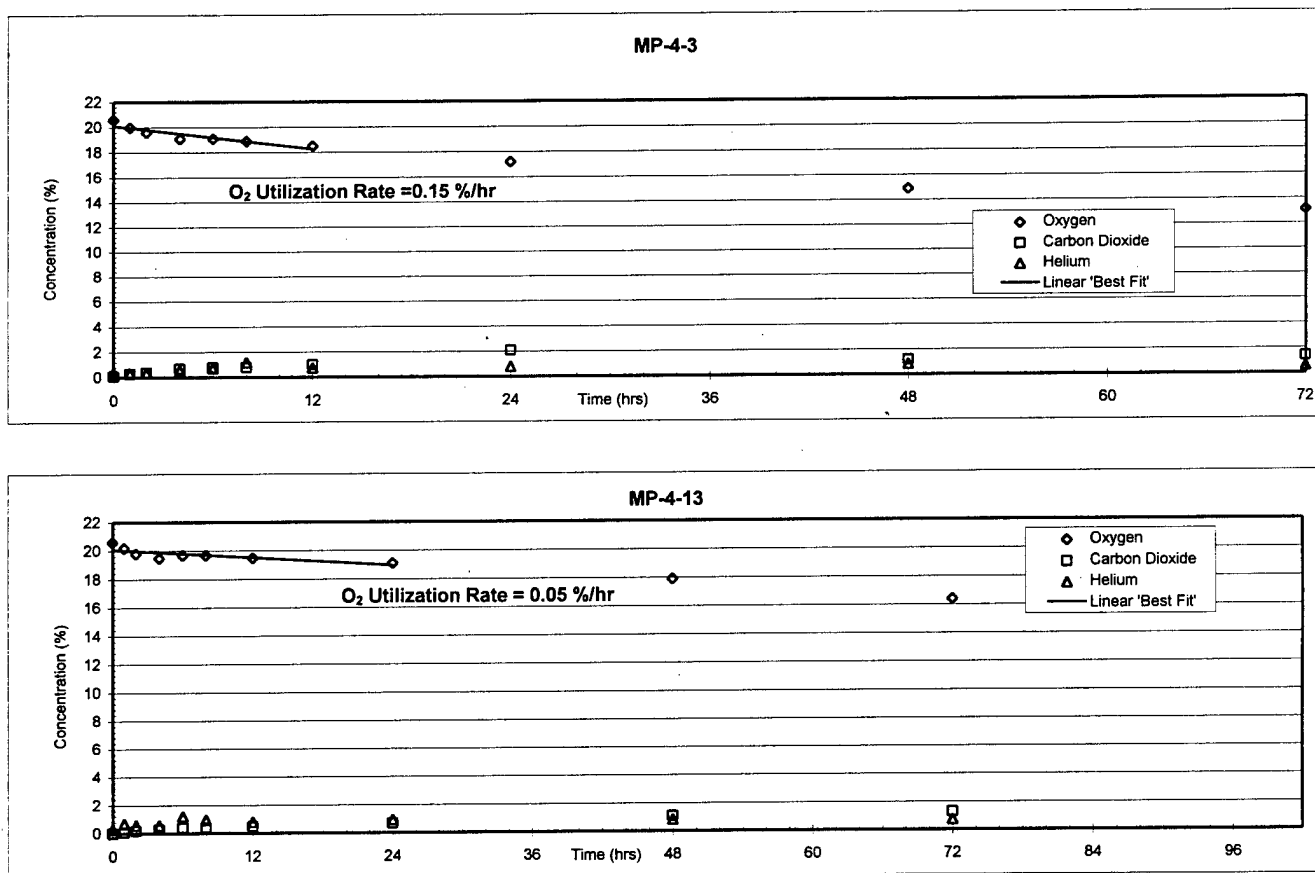
Figure A-2 Fall 1997 Respiration Test Results for MP-4-3 and MP-4-13 at the AHS

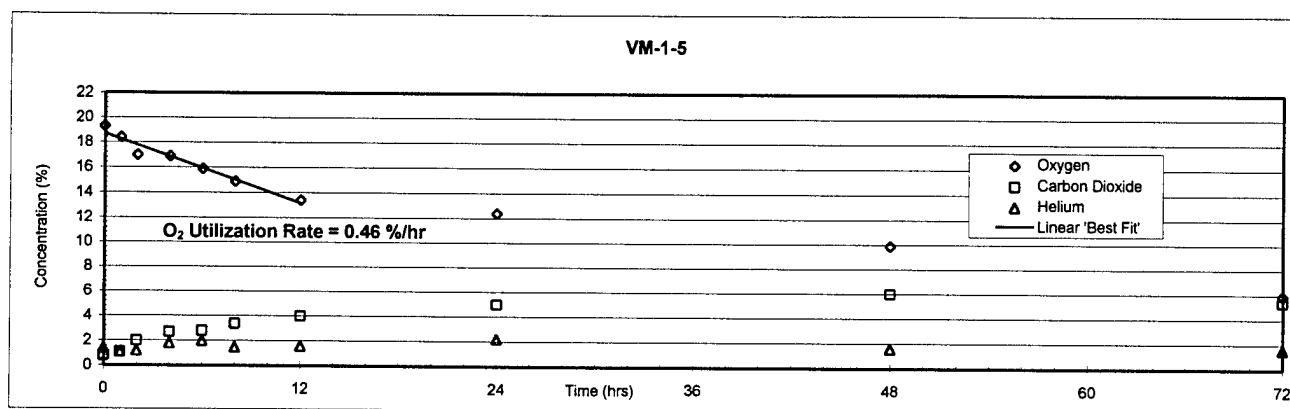
Figure A-3 Fall 1997 Respiration Test Results for VM-1-5 at the BXSS

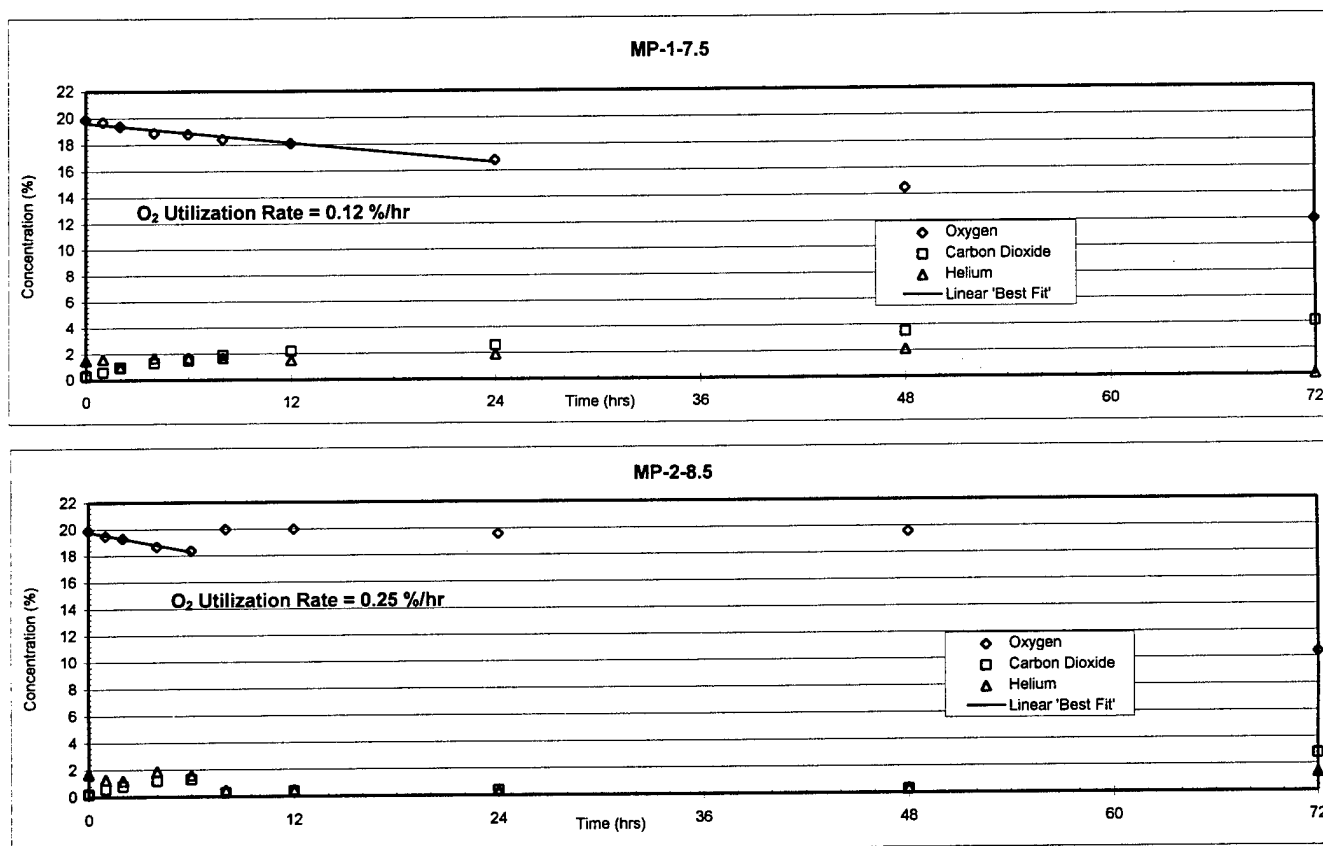
Figure A-4 Fall 1997 Respiration Test Results for MP-1-7.5 and MP-2-8.5 at the BXSS

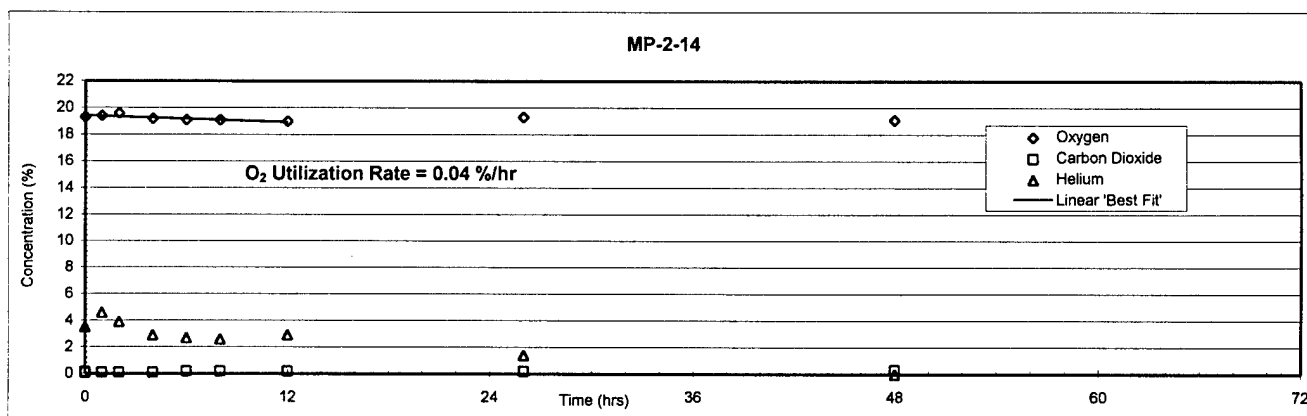
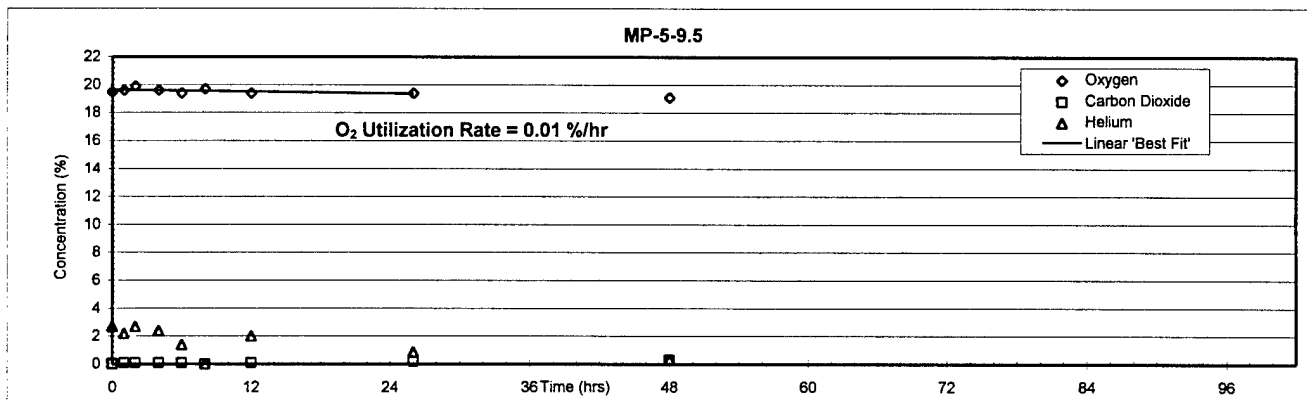
Figure A-5 Fall 1997 Respiration Test Results for MP-2-14 and MP-5-9.5 at the ES

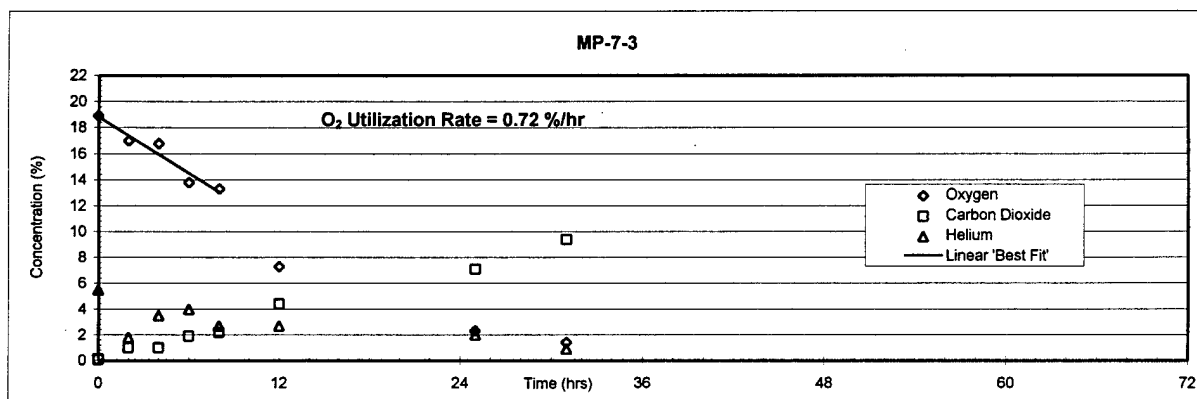
Figure A-6 Fall 1997 Respiration Test Results for MP-7-3 at the FJETC

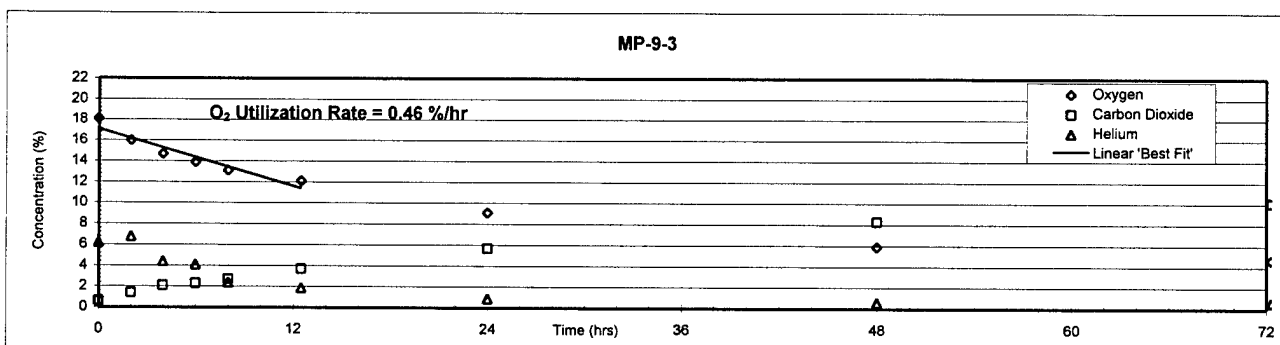
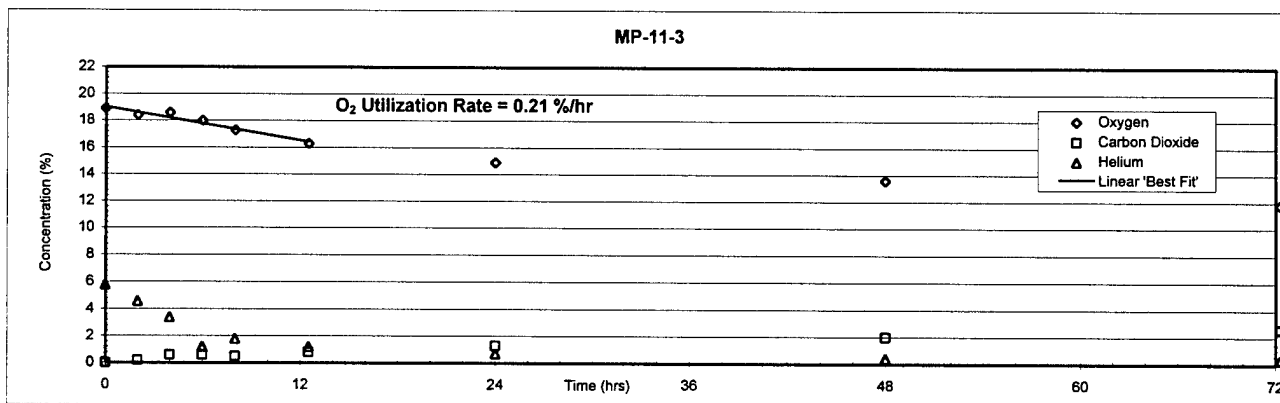
Figure A-7 Fall 1997 Respiration Test Results for MP-9-3, and MP-11-3 at the FTA

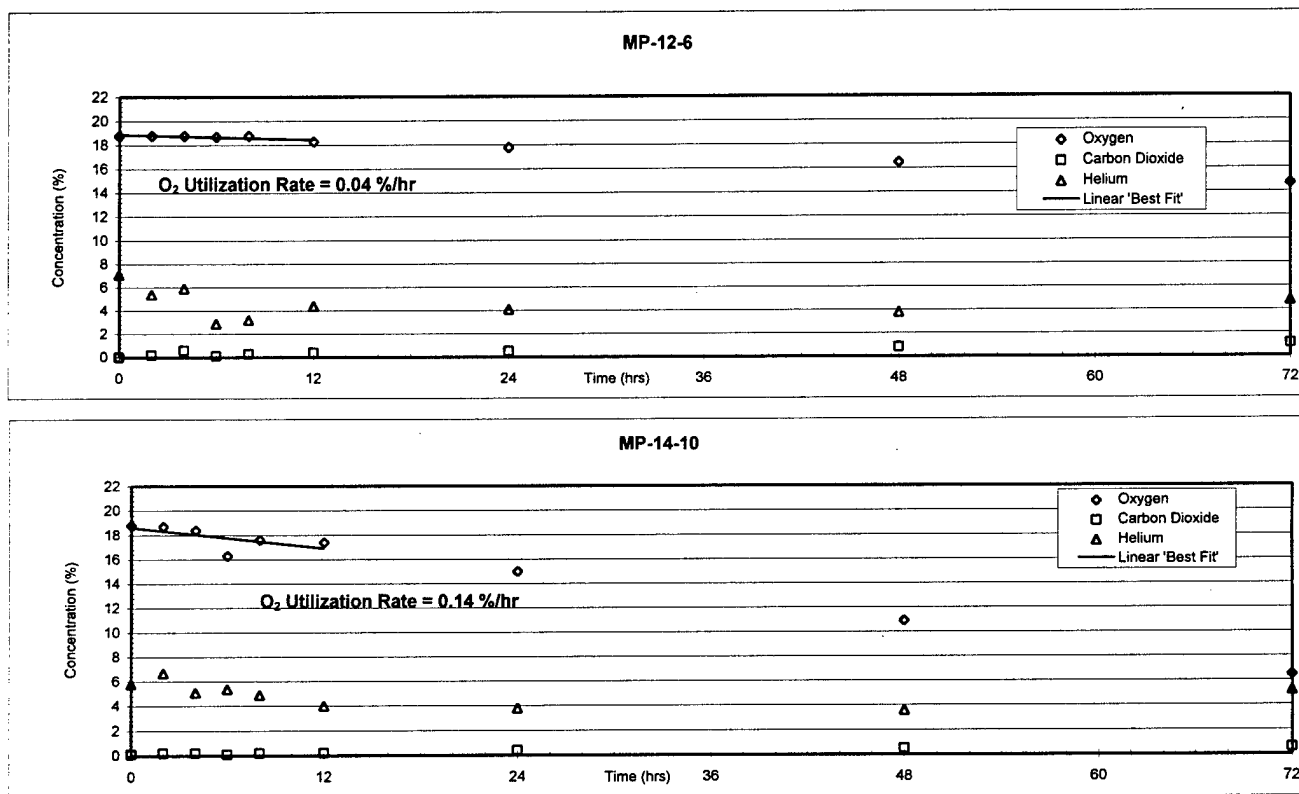
Figure A-8 Fall 1997 Respiration Test Results for MP-12-6 and MP-14-10 at the FTA

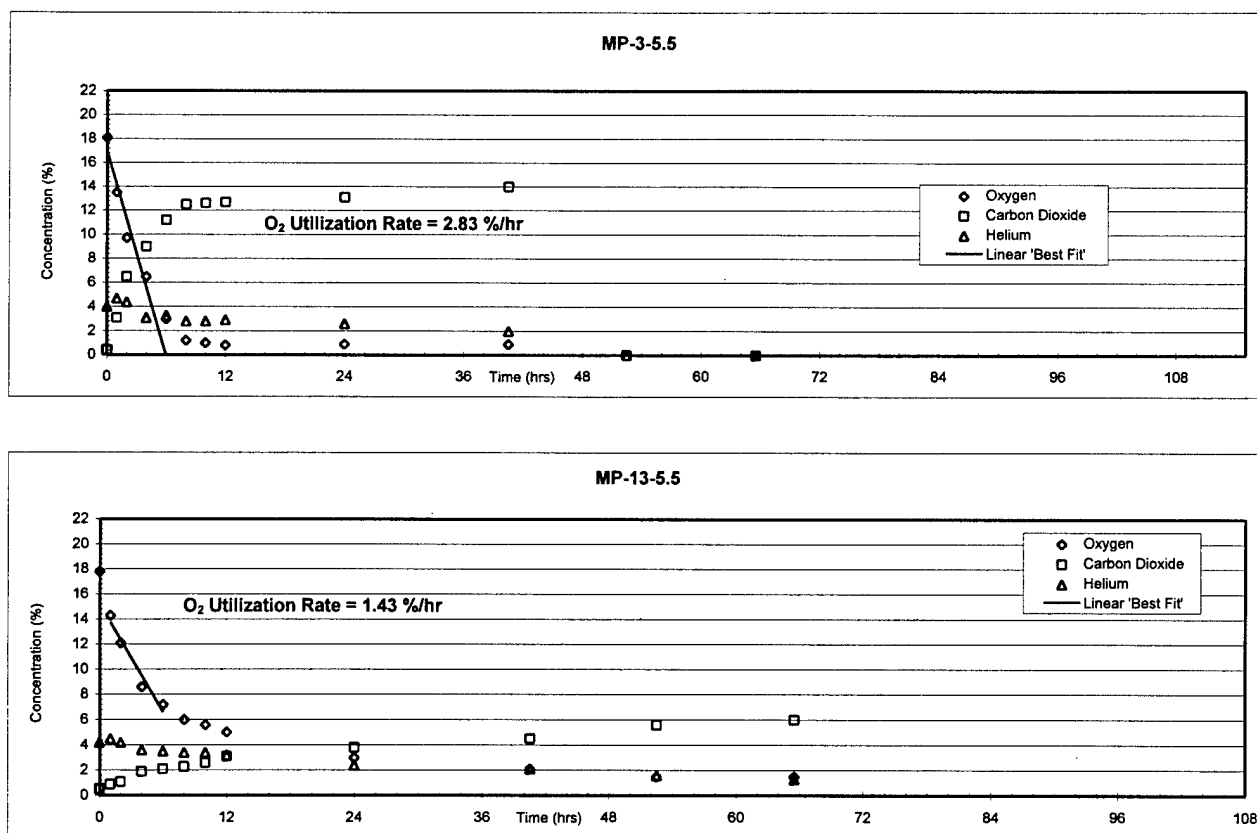
Figure A-9 Fall 1997 Respiration Test Results for MP-3-5.5 and MP-13-5.5 at FTF II

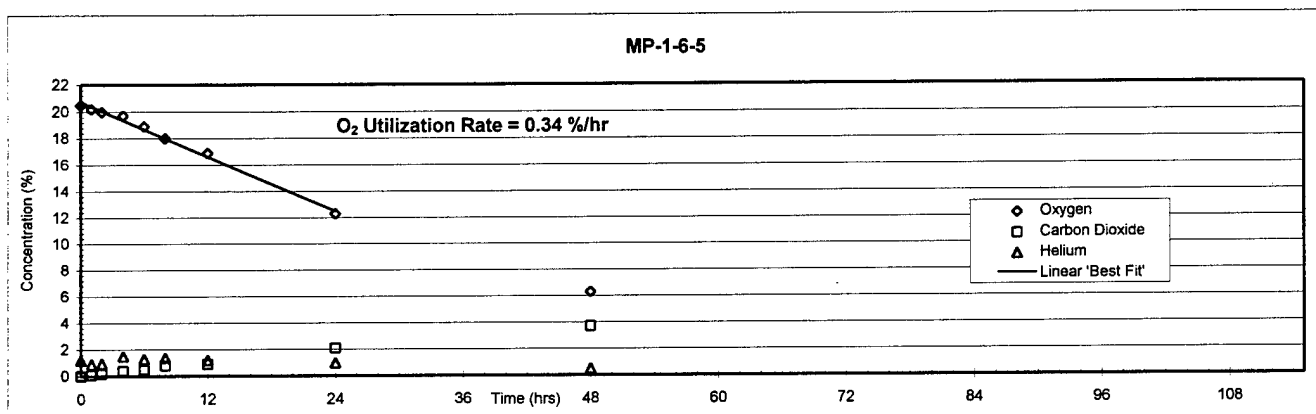
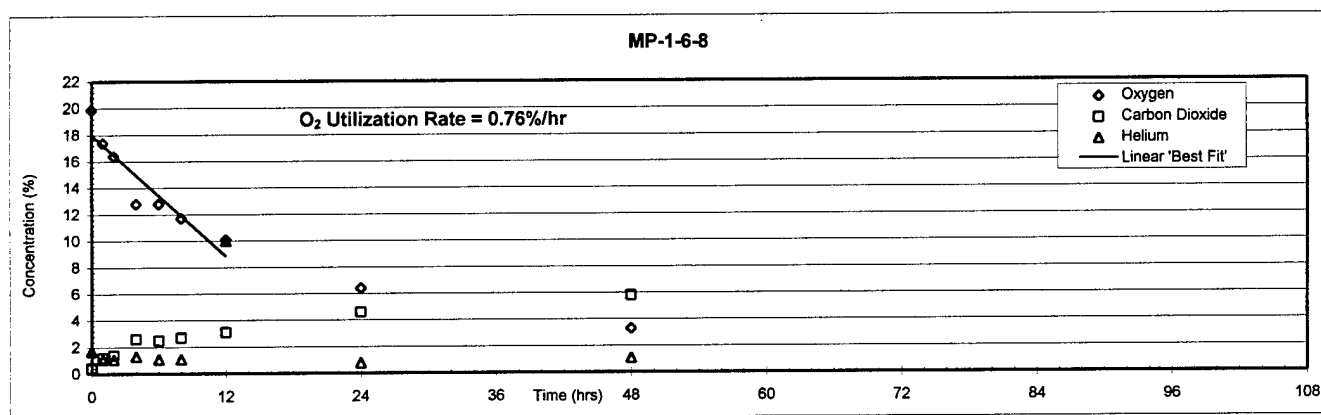
Figure A-10 Fall 1997 Respiration Test Results for MP-1-6-5 and MP-1-6-8 at NDA-1

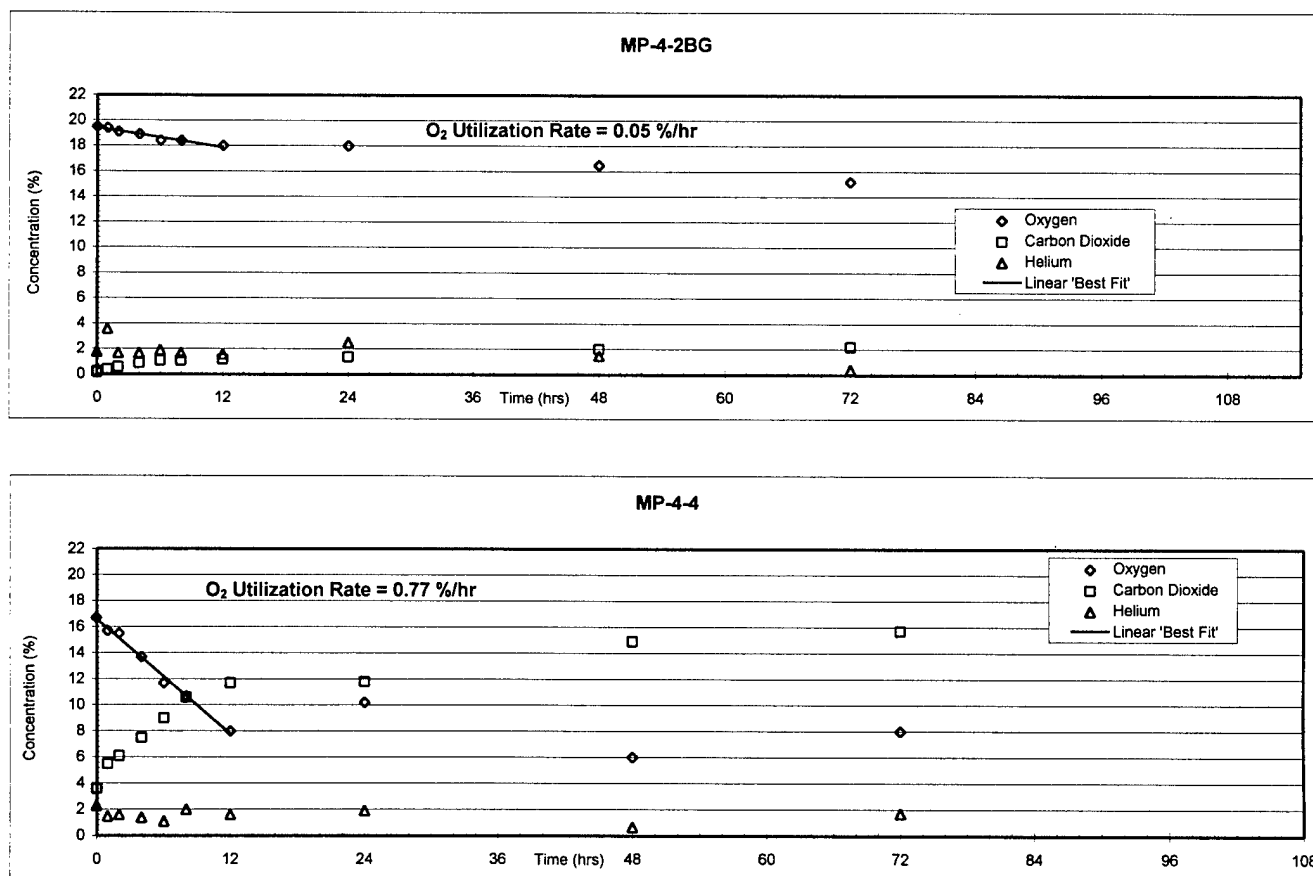
Figure A-11 Fall 1997 Respiration Test Results for MP-4-2BG and MP-4-4 at NDA-4

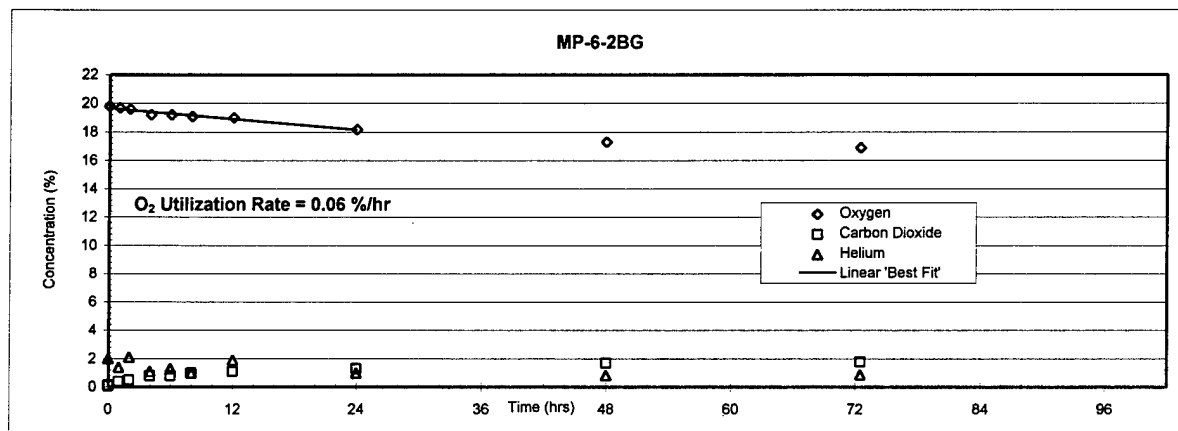
Figure A-12 Fall 1997 Respiration Test Results for MP-6-2BG at NDA-6

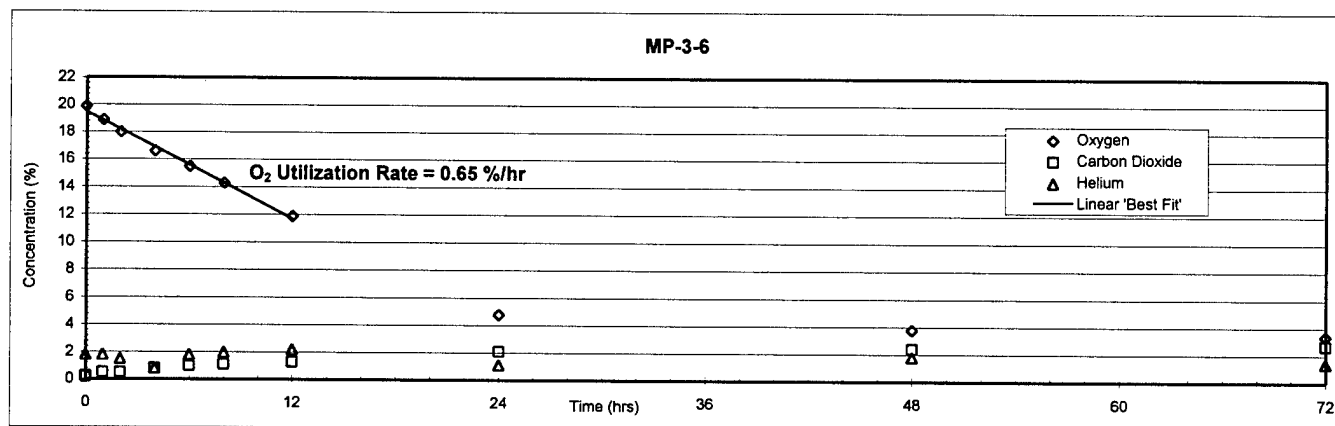
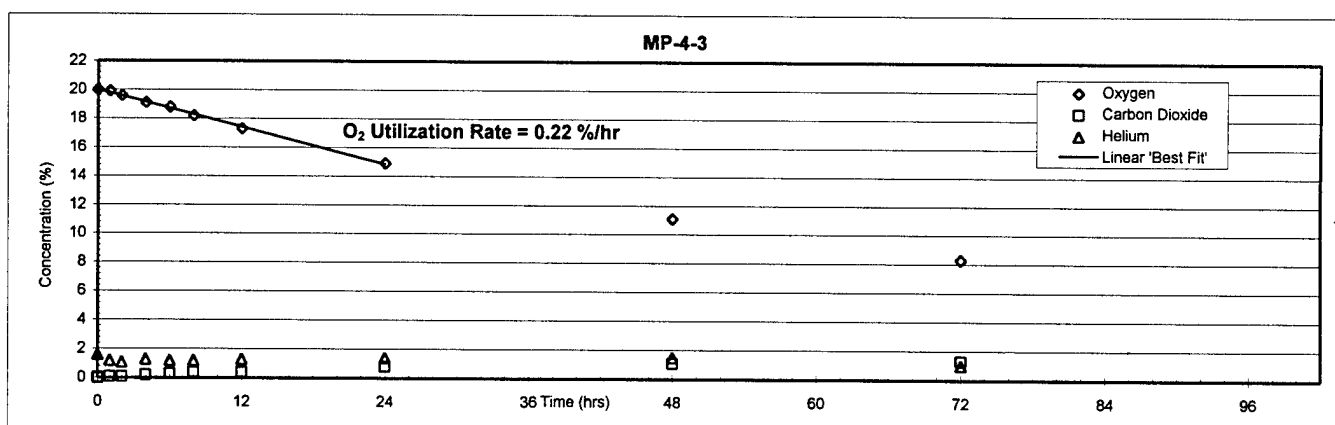
Figure A-13 Fall 1997 Respiration Test Results for MP-3-6 and MP-4-3 at the PPDP

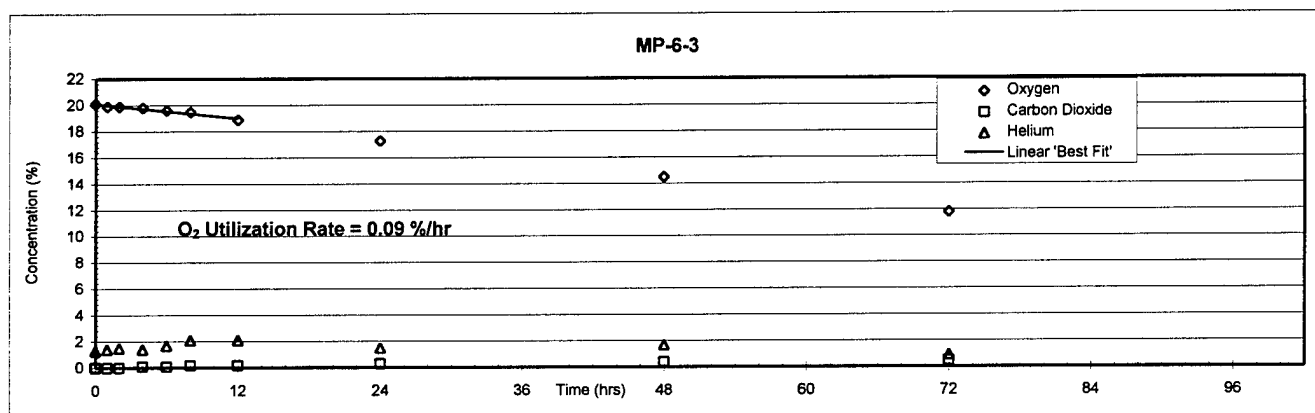
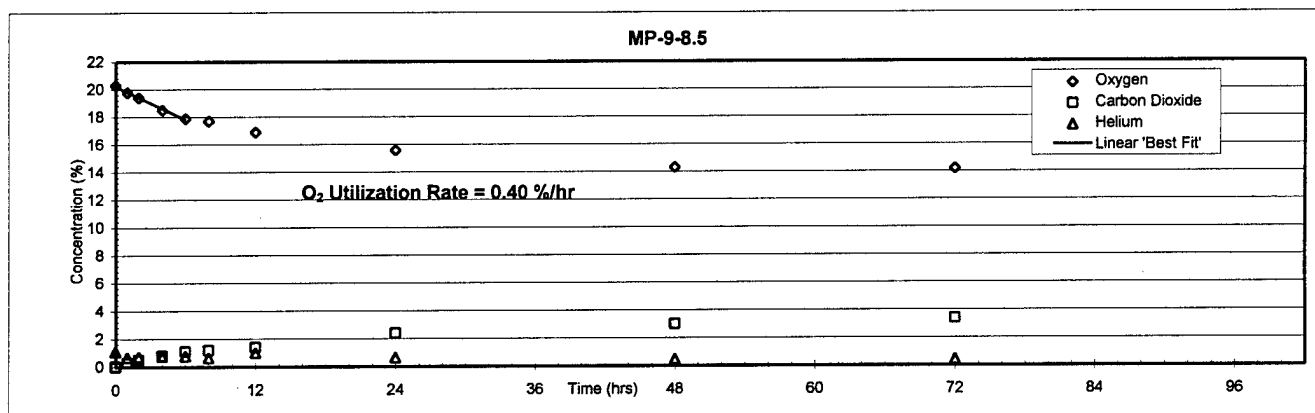
Figure A-14 Fall 1997 Respiration Test Results for MP-6-3 and MP-9-8.5 at the PPDP
